11-0509-006-03
August 13, 2018

Re: **Responses to Engineering Review Comments - Corbin Block**

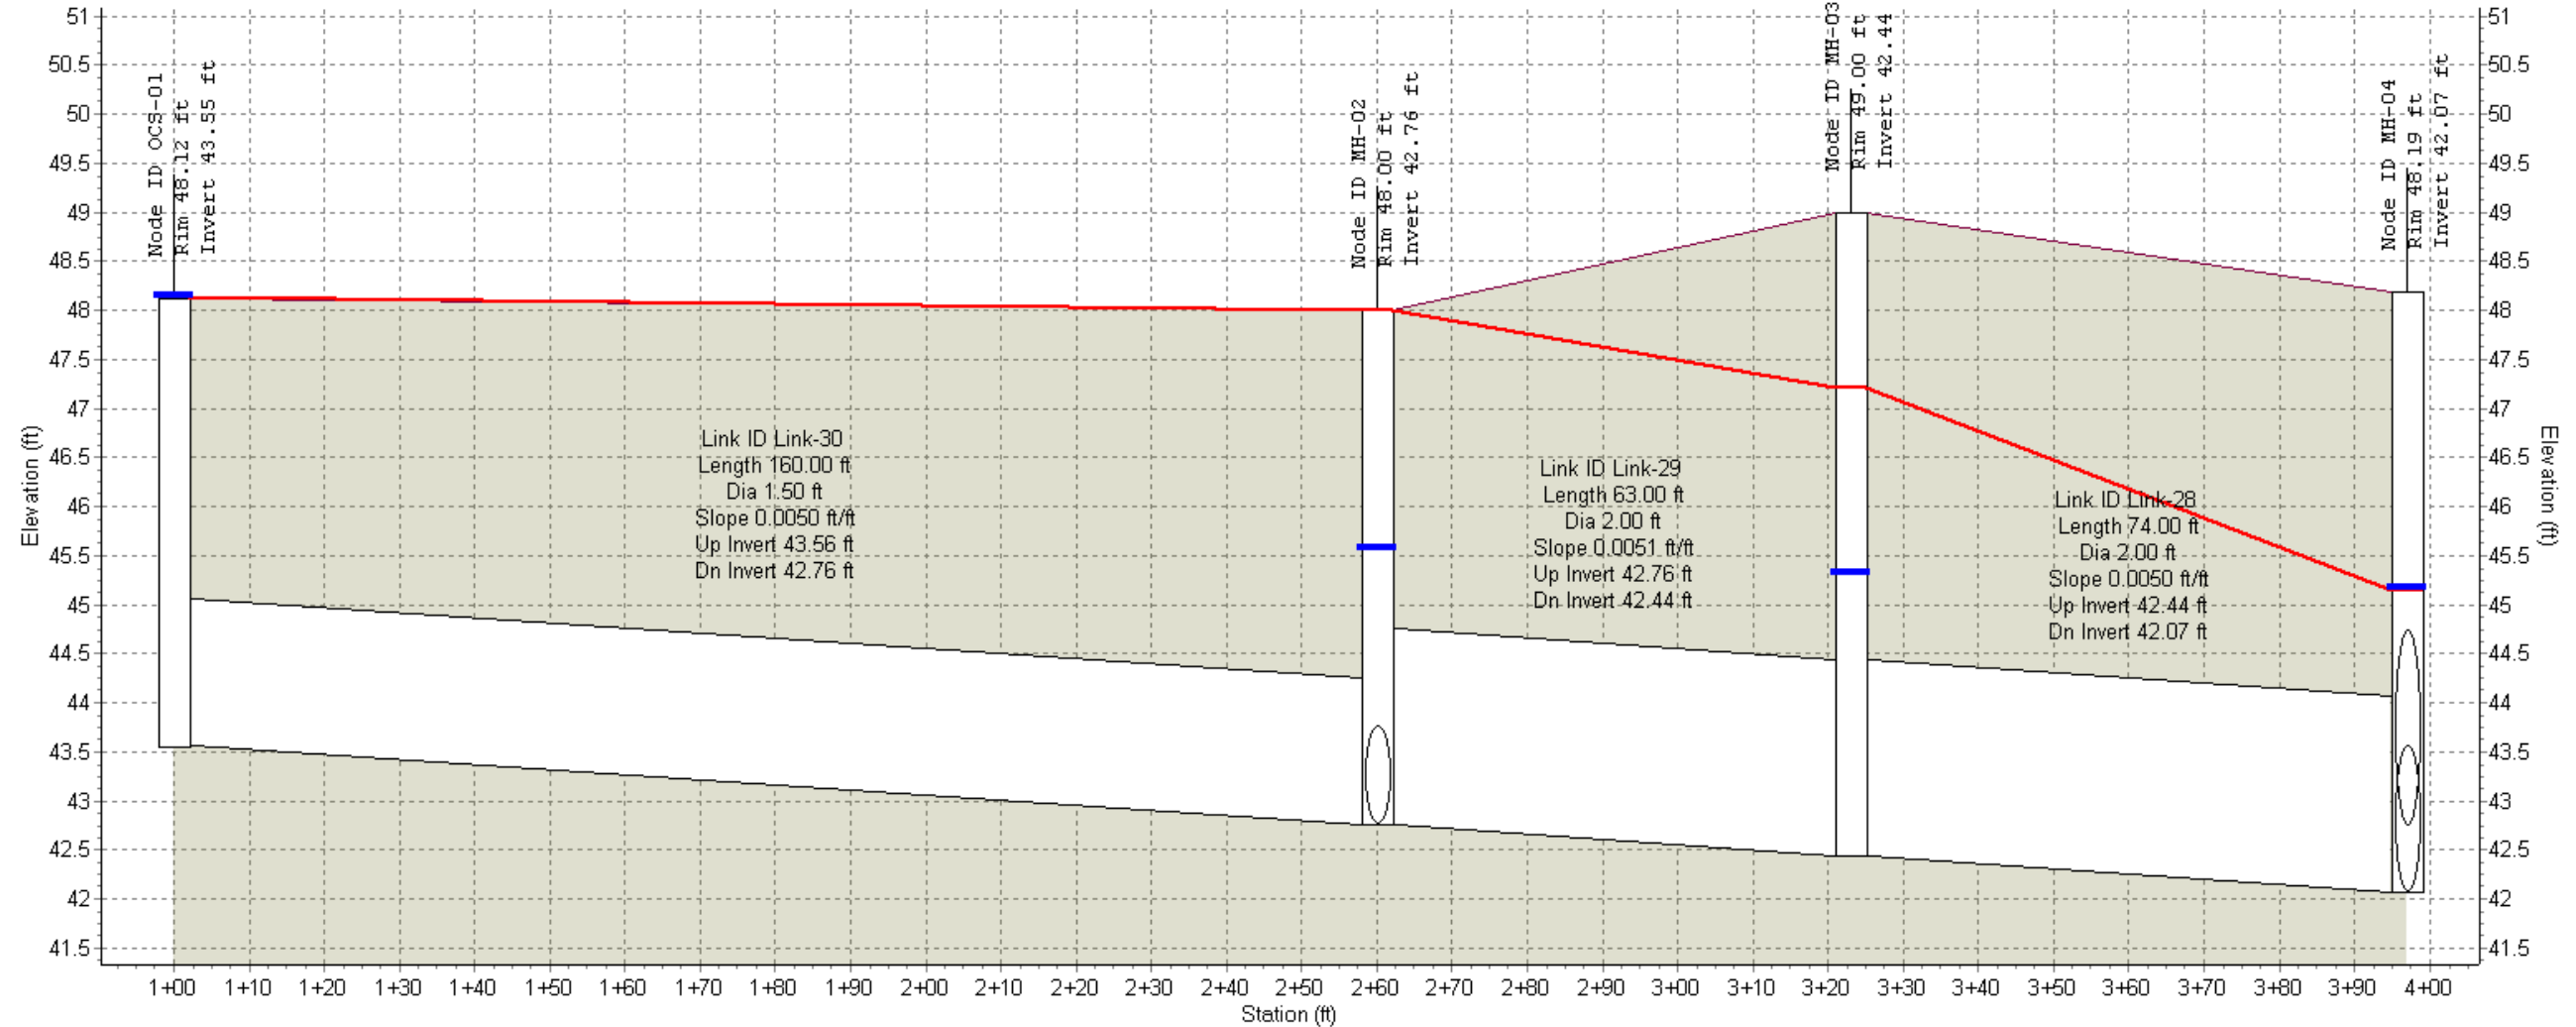
Corbin Block
Proposed Conditions - 50 Year Storm

| Node ID: | OCS-01 | | MH-02 | | MH-03 | | MH-04 |
| Rim (ft): | 48.12 | | 48.00 | | 49.00 | | 48.19 |
| Invert (ft): | 43.55 | | 42.76 | | 42.44 | | 42.07 |
| Min Pipe Cover (ft): | 3.06 | | 3.24 | | 4.56 | | 3.45 |
| Max HGL (ft): | 48.1300 | | 48.0000 | | 47.2200 | | 45.1500 |
| Link ID: | | Link-30 | | Link-29 | | Link-28 | |
| Length (ft): | | 160.00 | | 63.00 | | 74.00 | |
| Dia (ft): | | 1.50 | | 2.00 | | 2.00 | |
| Slope (ft/ft): | | 0.0050 | | 0.0051 | | 0.0050 | |
| Up Invert (ft): | | 43.56 | | 42.76 | | 42.44 | |
| Dn Invert (ft): | | 42.76 | | 42.44 | | 42.07 | |
| Max Q (cfs): | | 10.63 | | 10.46 | | 12.46 | |
| Max Vel (ft/s): | | 6.01 | | 4.72 | | 4.52 | |
| Max Depth (ft): | | 1.50 | | 2.00 | | 2.00 | |

Update MH#7 in the 50-year HGL profile to have a tailwater equal to the 50-year peak water elevation of the south infiltration system (44.53). Take the maximum hydraulic grade line from the updated HGL model at OCS-01 and input it into the Hydraflow Model as the tailwater applied to the Courtyard Infiltration outlet structure. Provide the updated 50-year profile and updated 50-year Hydraflow Model to examine the performance of the Courtyard Infiltration system during a 50-year storm event. Update the drainage, if necessary, to make sure the Courtyard Infiltration system will function without surcharging to grade during the 50-year storm event. Resulting in flow reversals

Response: The 25-year flow rate (38.94 CFS) cited in your comment above is not correct. The 25-year flowrate reported by the modeling software is inclusive of flow reversals from the tailwater condition when the outlet pipes are submerged. The flow rate generated on site for the 25-year storm (without including the additional volume in the pipes from an elevated tailwater condition) is 29.6 CFS. The twin 18-inch pipes were initially proposed on our drawings due to concerns with the crossing of the existing sanitary sewer main in Old Kings Highway South. We have since been provided with additional as-built information on the existing sewer that indicates the main is a syphon at this location; therefore, we are not limited by a potential gravity sewer conflict as we had initially anticipated. In light of this information we have revised the outlet to be a 30-inch RCP to match the upstream pipe diameter. The revised drawings reflecting this change have been included for your review.

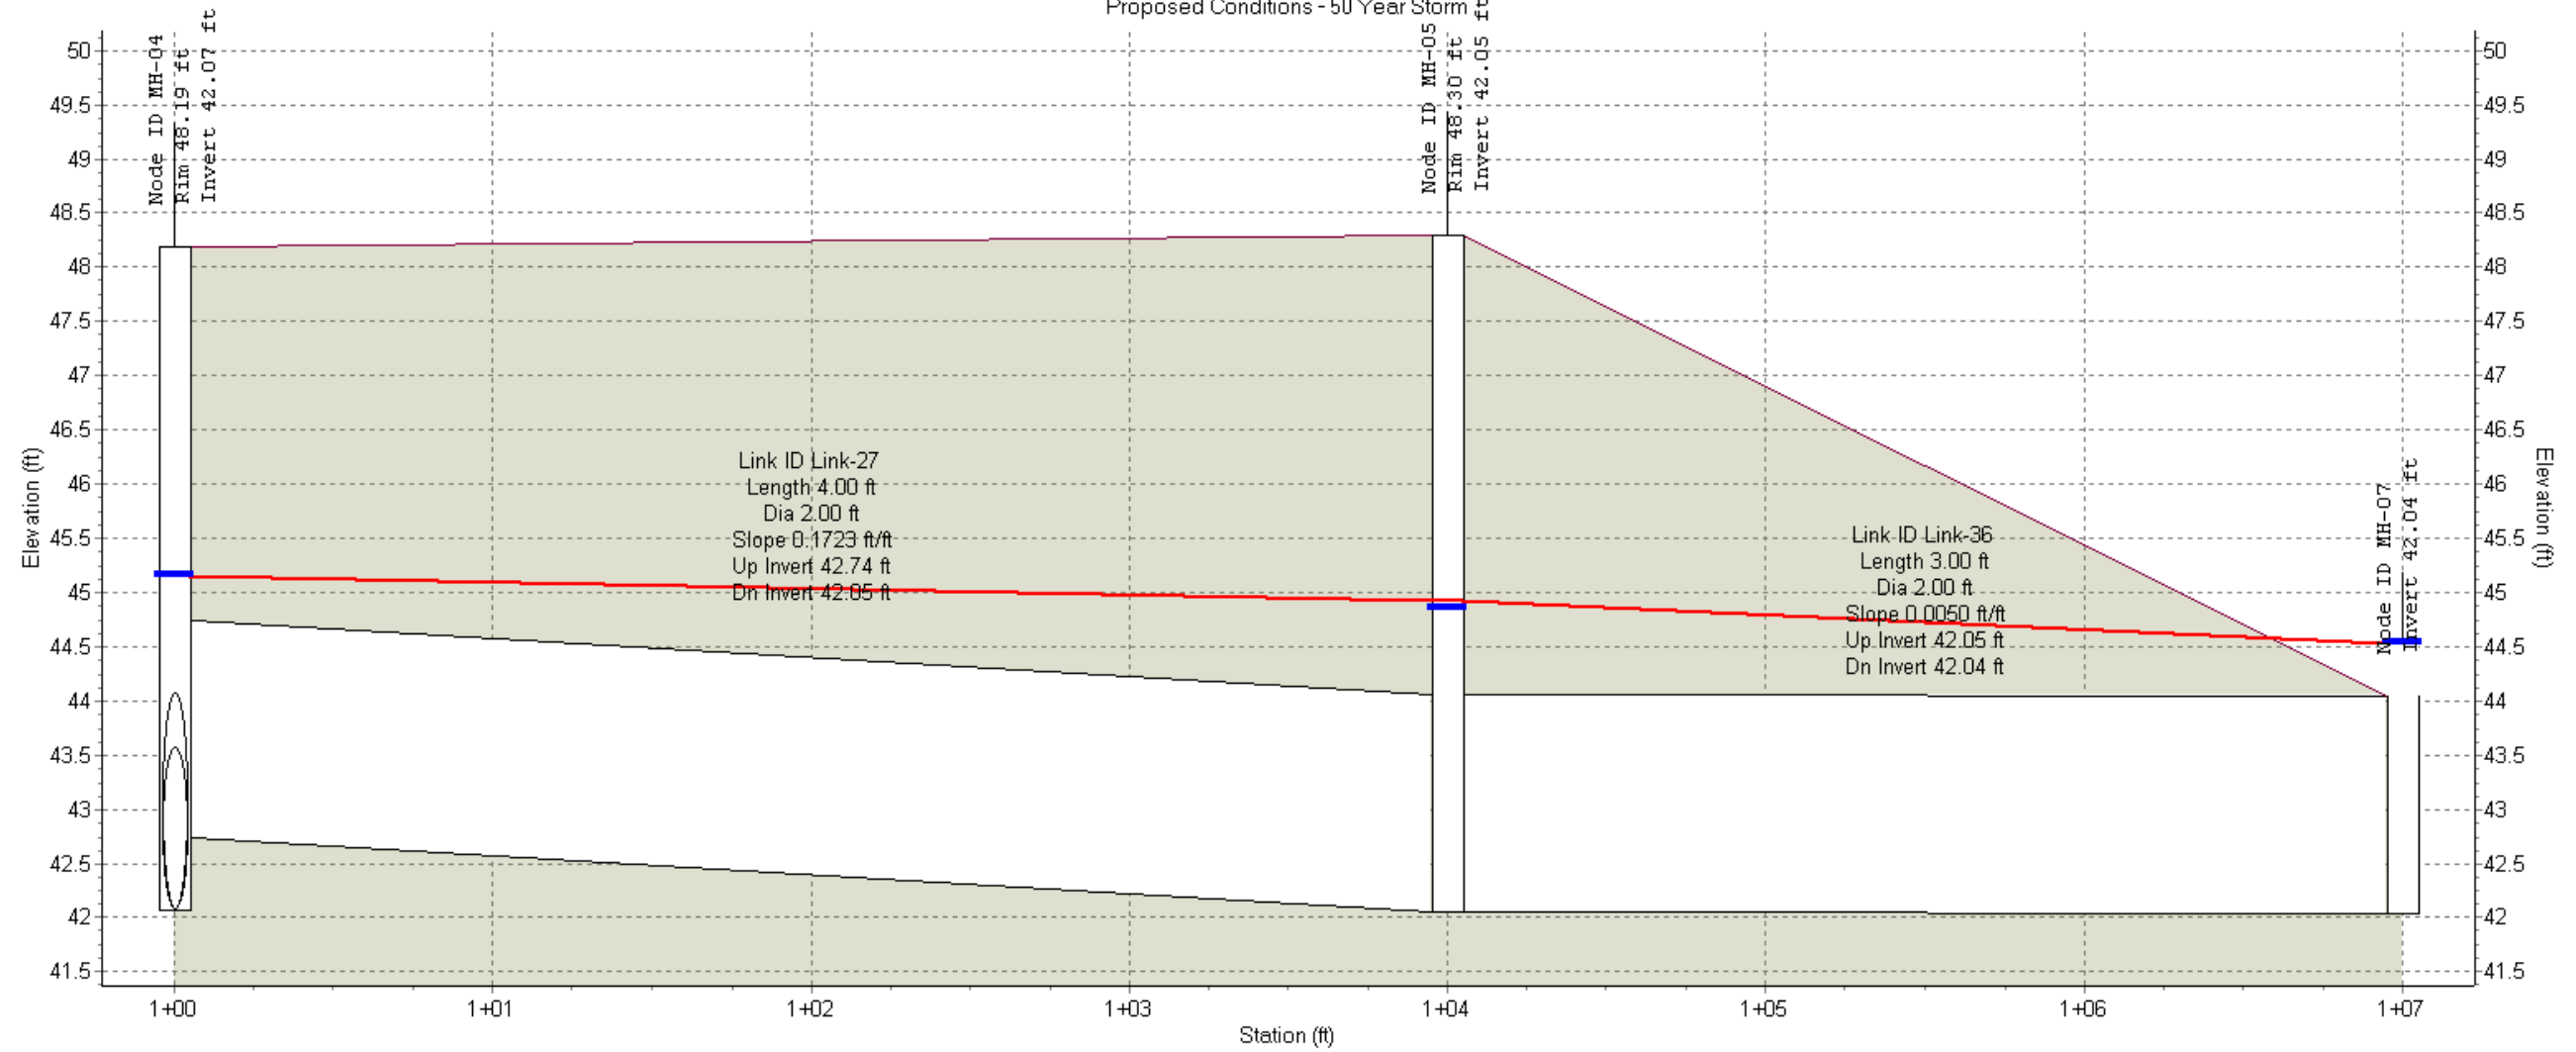
Corbin Block
Proposed Conditions - 50 Year Storm

| Node ID: | MH-04 | MH-05 | MH-07 |
| Rim (ft): | 48.19 | 48.30 | |
