Site Engineering Report

Stone Residence
108 Five Mile River Road
Darien, Connecticut

DiVesta Civil Engineering Associates, Inc.

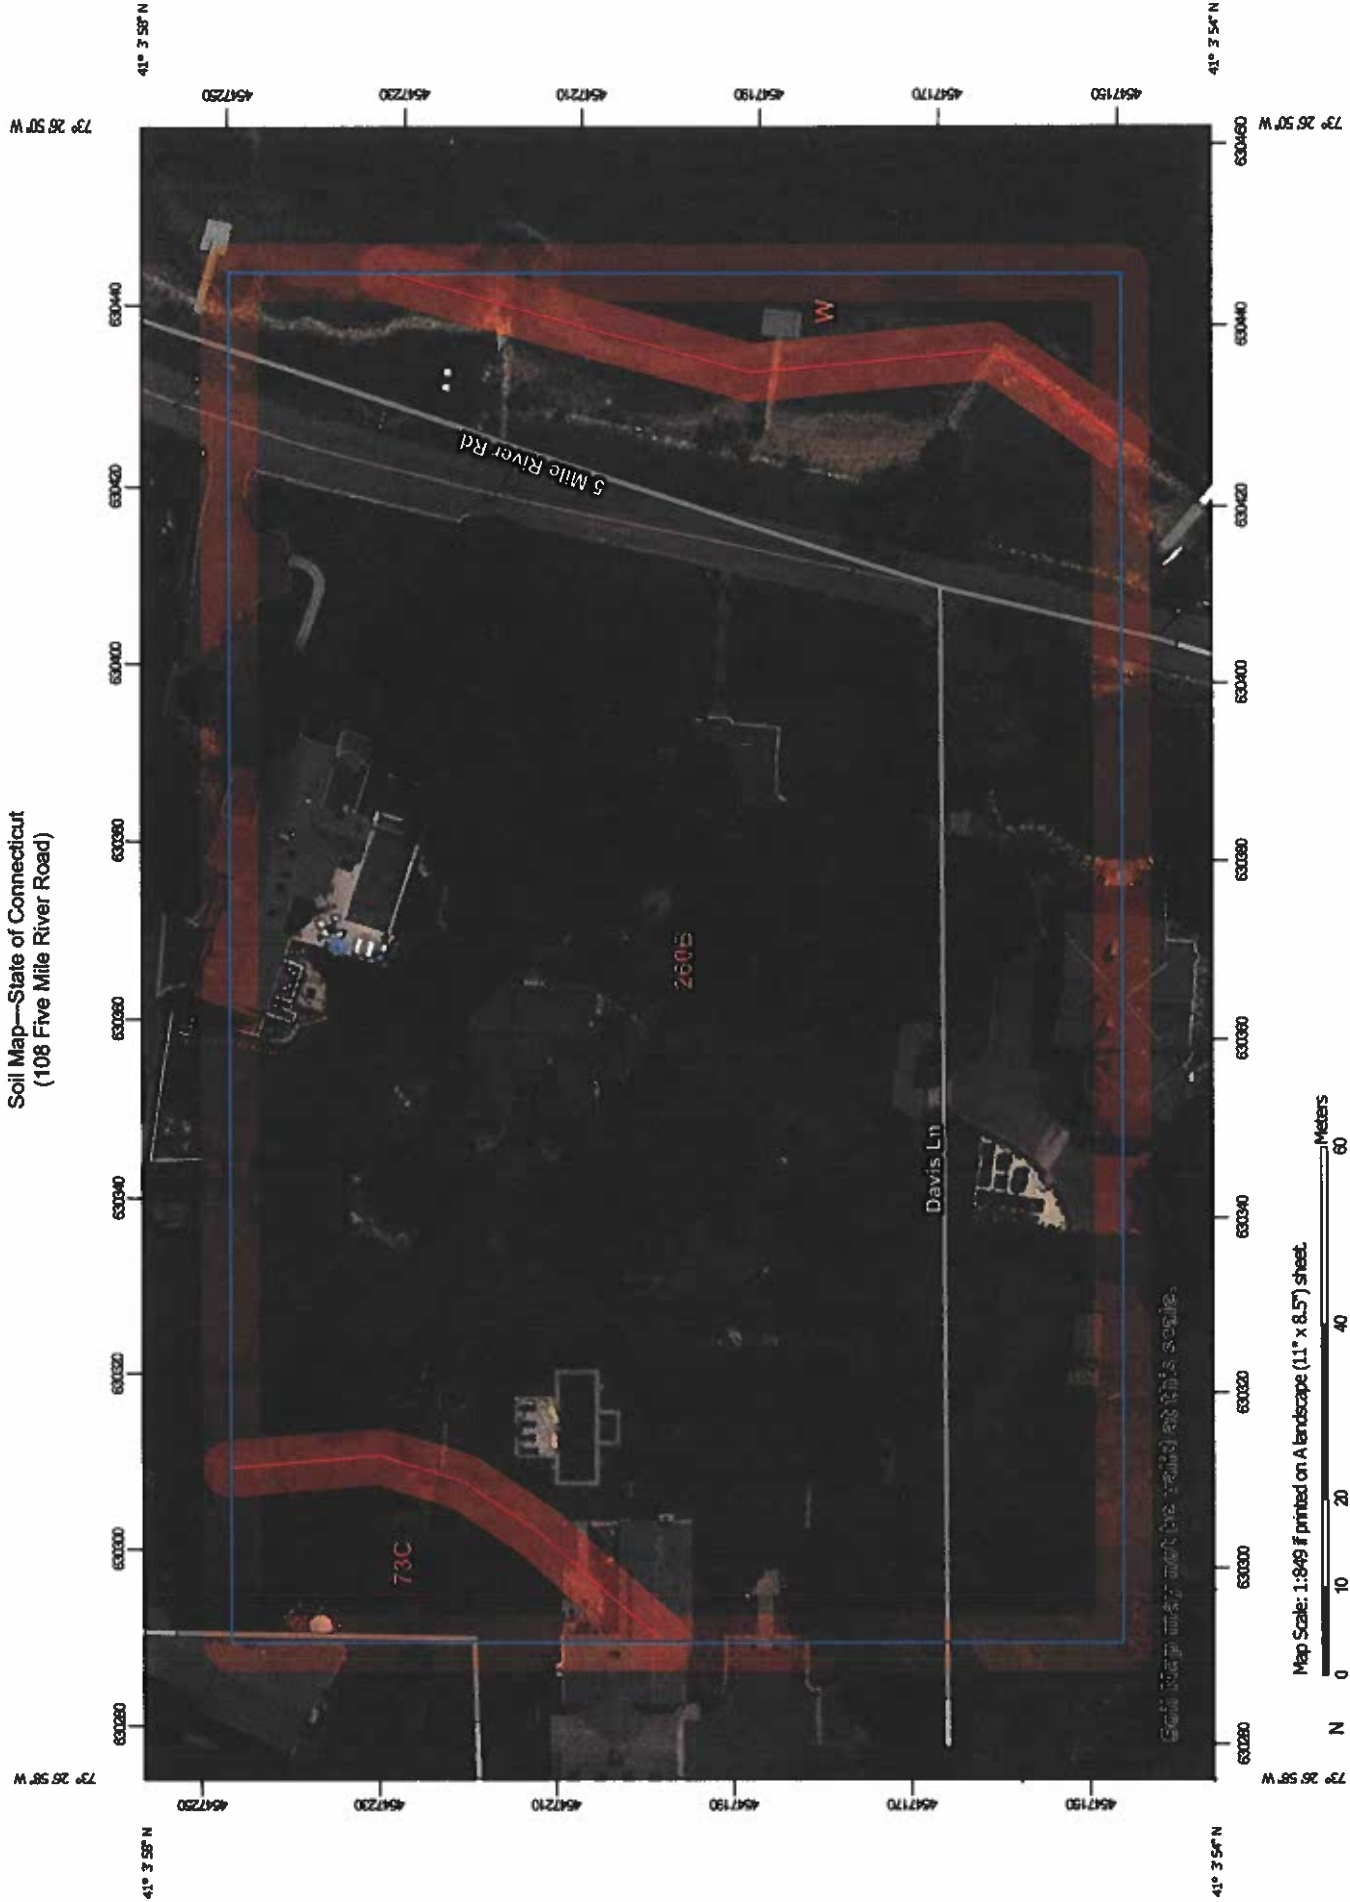
Soil Map—State of Connecticut
(108 Five Mile River Road)

Soil map may not be valid at this scale.

Map Scale: 1:849 if printed on A landscape (11" x 8.5") sheet.

Enlargement of maps beyond the scale of mapping can cause misunderstanding of the detail of mapping and accuracy of soil line placement. The maps do not show the small areas of contrasting soils that could have been shown at a more detailed scale.
